Beech Tree Assessment

83 Longwood Ave, Brookline, MA

Prepared by:
Howard Gaffin
MCA #1468
BCMA # NE-0363B
RCA #458

July 9, 2021

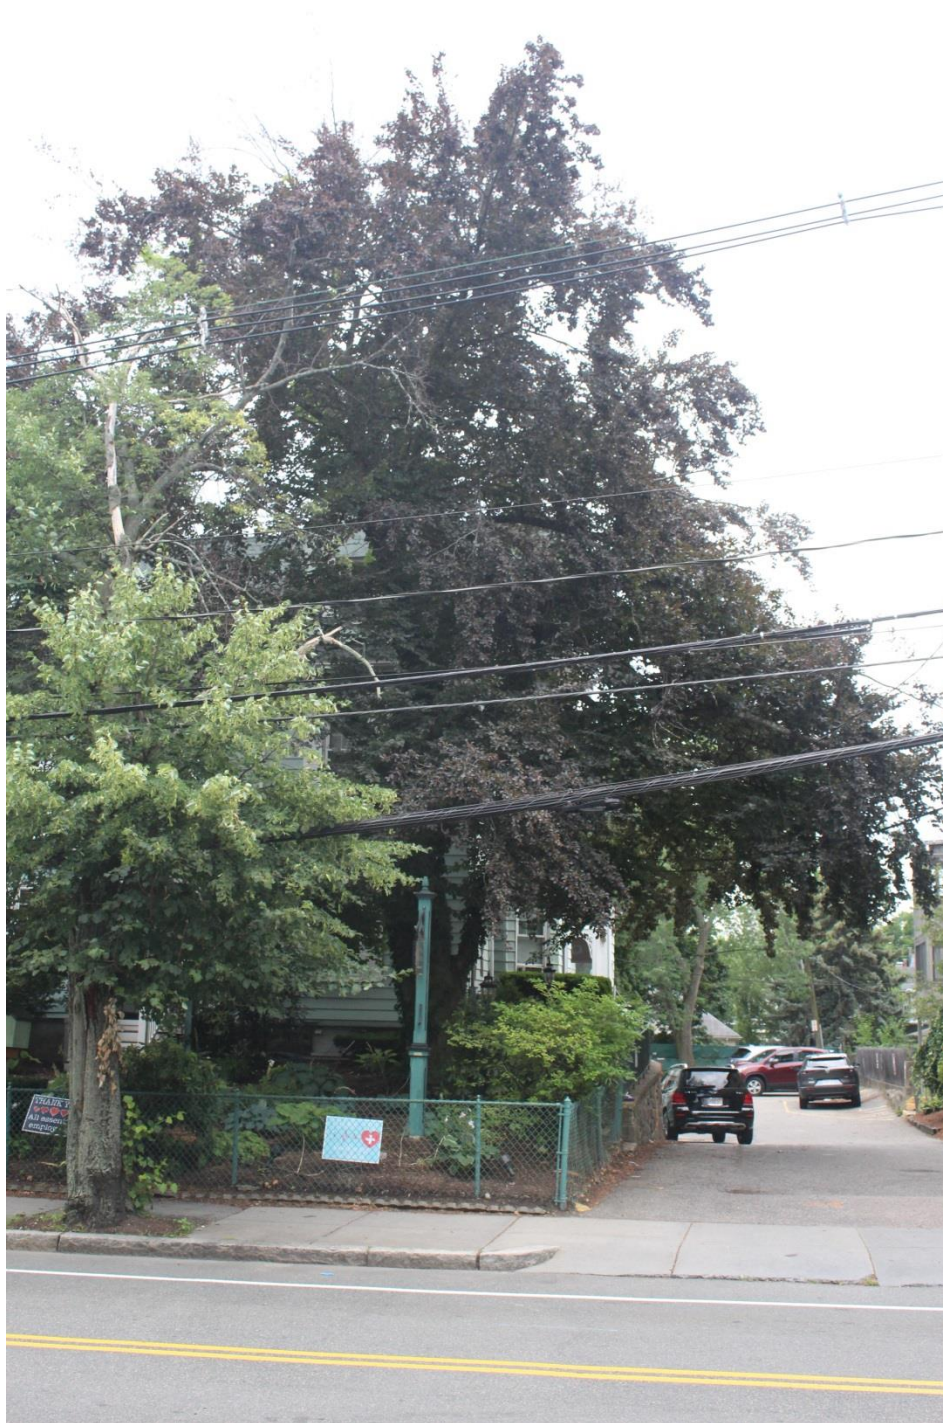
Image 1 – Tree on Site

I arrived at the site at 83 Longwood Ave, Brookline, MA on July 1, 2021 (Site map, pg. 4). The large European Copper beech (*Fagus sylvatica* "purpurea") measured 36" dbh, and approximately 50 feet in height and width. The tree is located to the northwest of the existing building (Image 1, pg.5). The root zone and crown are constricted by the building to the south, a retaining wall to the east, and the street to the north. A street tree is also located to the north. Additional foot paths and walkways are within the root zone and close to the trunk (Images 2-4, pg. 6).

A view of the tree looking south

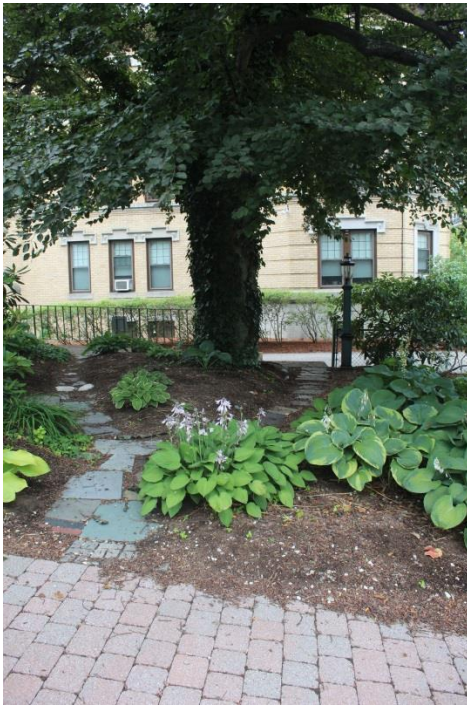
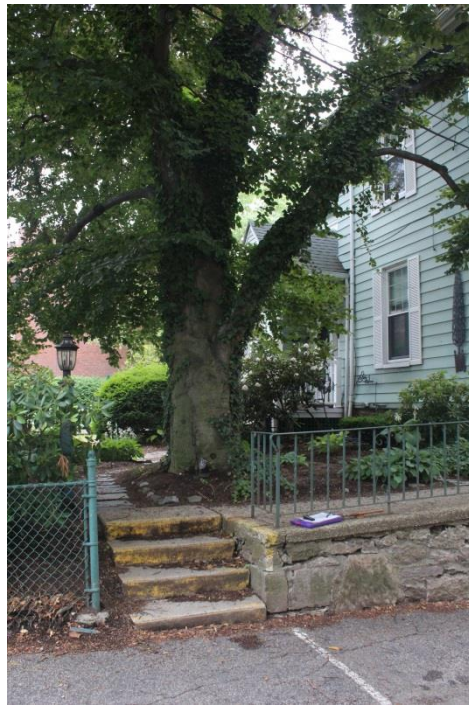
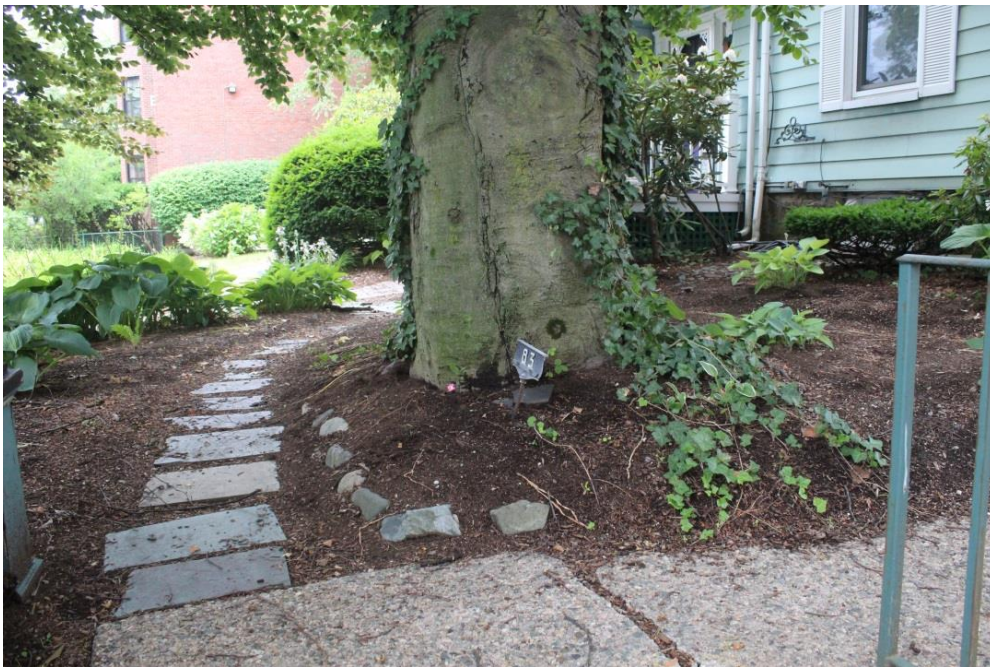
Images 2-4 - Root zone

The area directly around the lower trunk has been filled with soil. No clear root collar or buttress roots are visible. Flat areas where the trunk enters the ground are potential signs of girdling roots.

This large specimen has somehow survived the ravages imposed upon it in a tough location, but is now showing signs of decline, consistent with the limited and compacted root zone. Additional space must be provided for preservation to be realistic. A tree of this size, species and condition would require a large area to be undisturbed (Tree Protection Zone, pg. 9).

*Above: Views of the root area from west and east. The roots are confined and the soil compacted.
Below: A closer view of the trunk shows the lack of a visible root crown or buttress roots.*

- Careful removal of the existing building foundation and the retaining wall
- Providing additional space for root growth
- Root crown excavation and root pruning
- Soil rehabilitation and moisture management
- Targeted pruning
- Monitoring and treating for pathogens.

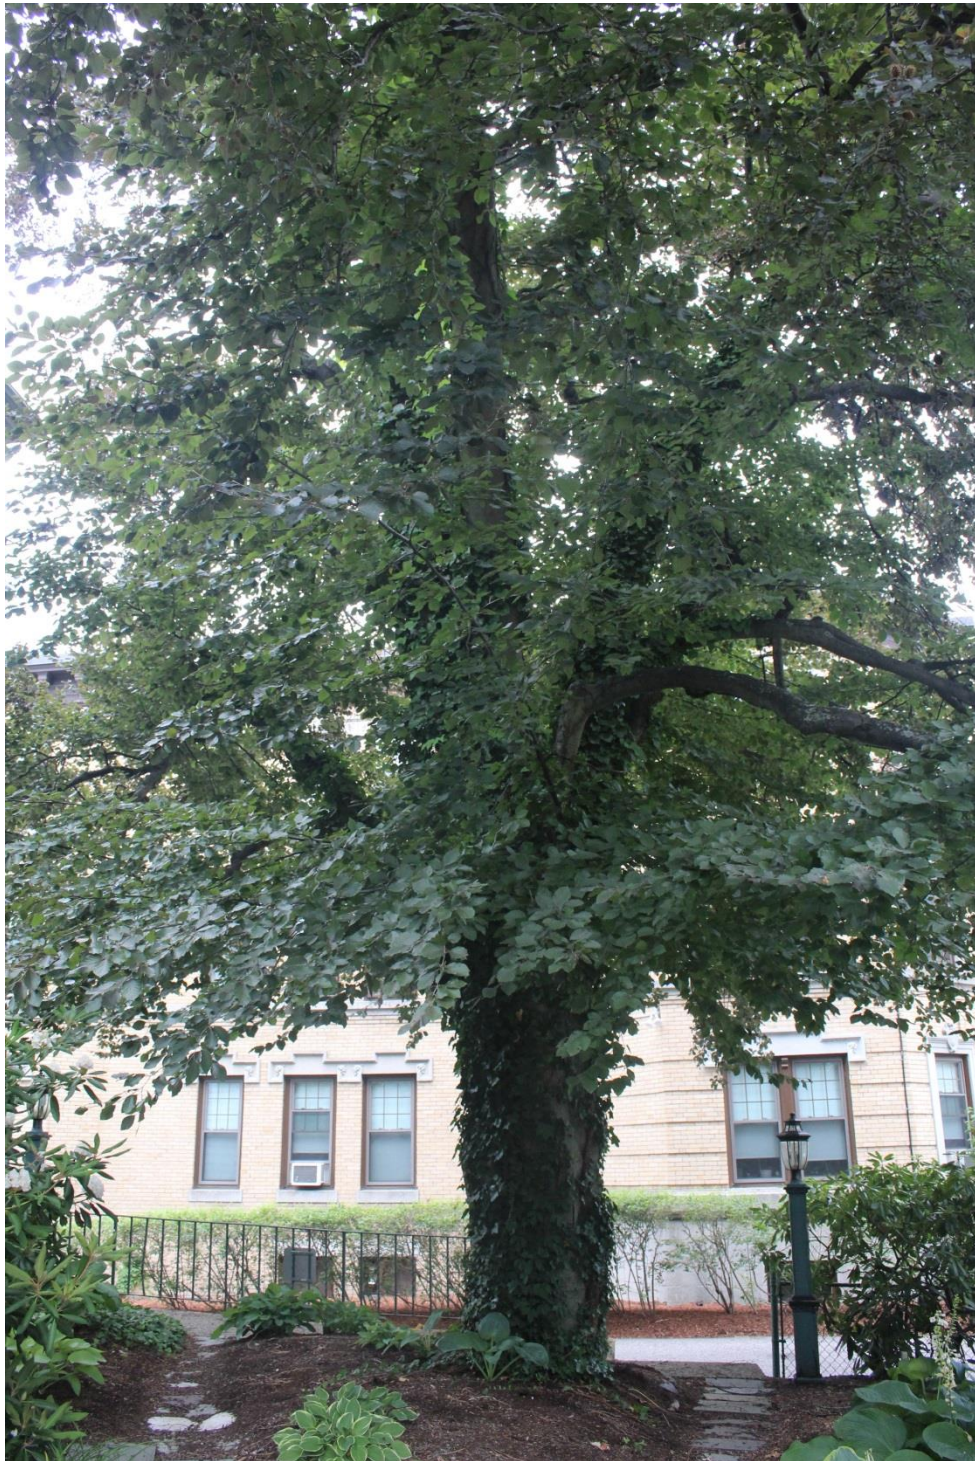
Image 5 - Structure

Parts of the trunk were not visible due to some Boston ivy, but it appears solid. The first scaffold limb arises from the trunk at approximately 6 feet and grows toward the building. Co-dominant scaffolds arise at 12 feet. The unions are good and no defects were noted. Besides a large broken branch stub on the south side, crown structure and branch unions are also in good condition (Image 5, pg. 7).

Boston ivy grows up the trunk and partially obscures the view, but the trunk and tree architecture appear sound

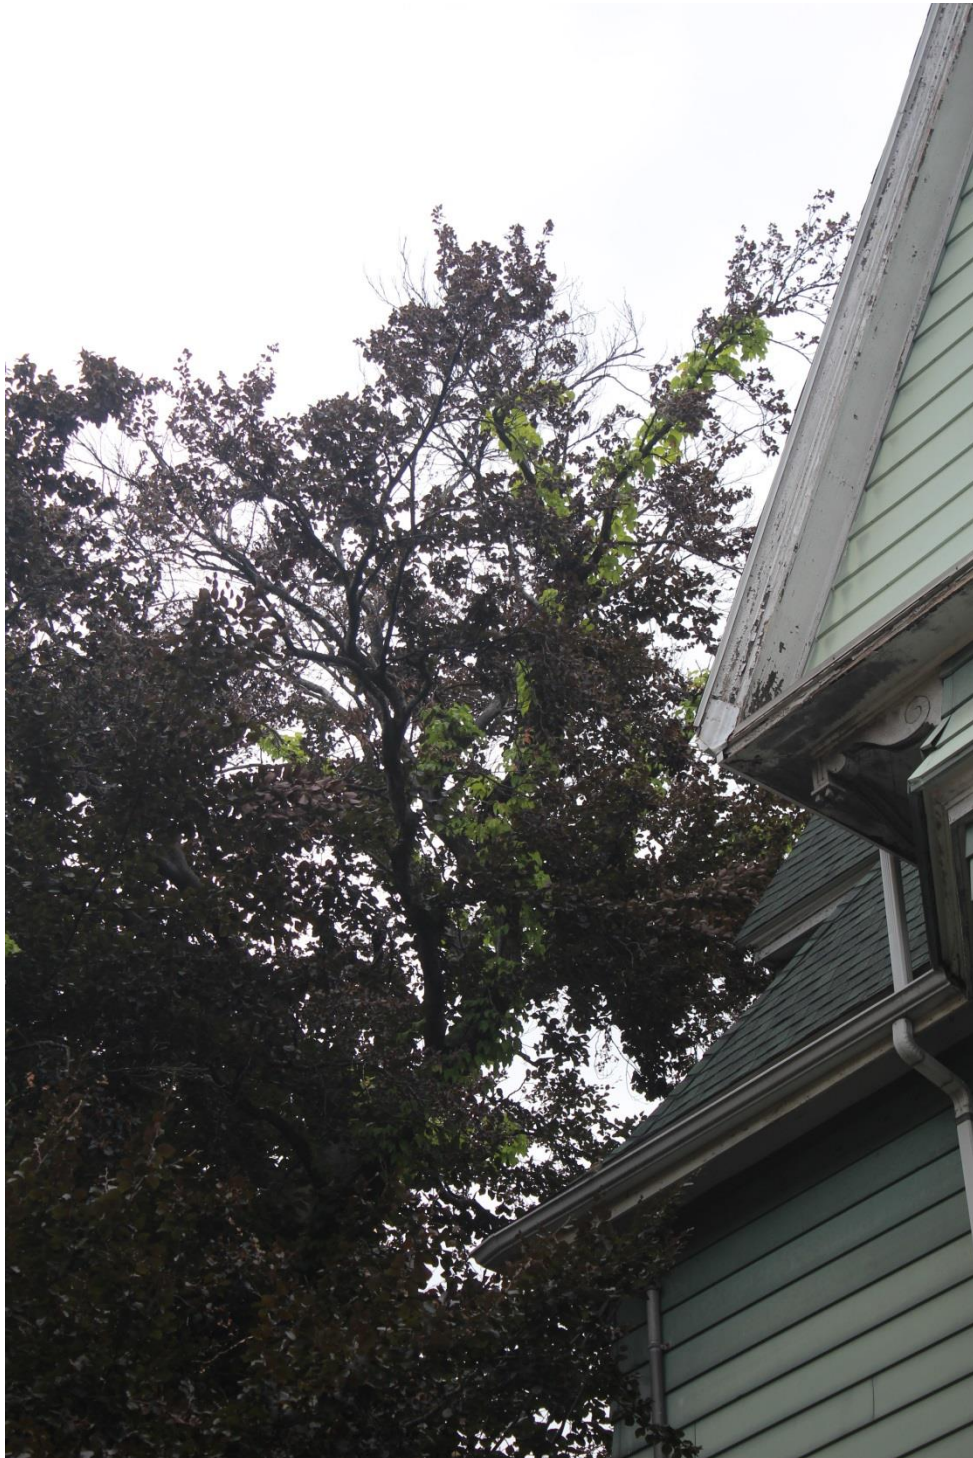
Image 6 – Crown in Decline

The upper crown exhibits a fair amount of die-back, with small, sparse foliage especially evident on the major scaffold to the south (Image 6, pg. 8).

Die-back and sparse foliage in portions of the upper crown are a clear indicator of decline.
